**RE: Dunn-Erwin LCID Landfill Seep Response**  
**Harnett County, NC (Permit No. 43-02)**

Smith Gardner, Inc. (S+G), on behalf of Harnett County, presents this summary report regarding the recent leachate seep response at the Dunn-Erwin LCID landfill facility (DELF) in Dunn, North Carolina. As you are aware, in less than 24 hours, from June 7-8, 2013 the facility received over eight (8) inches of rain at the site resulting from inclement weather patterns in the region; subjecting the site to leachate response actions at three (3) locations as follows:

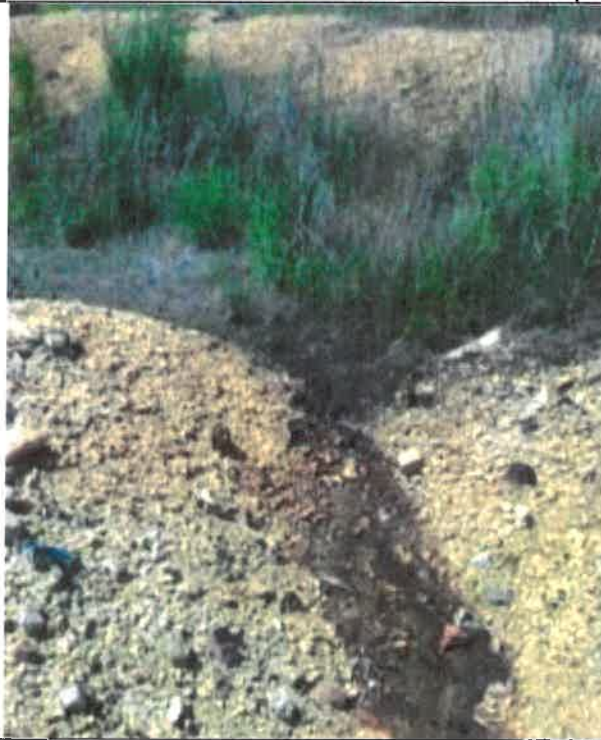
**Photo No.**  
1

Seep within the limits of the C&D site.

A small seep was identified on the C&D landfill slope, where it appeared to flow into a drain. This slope drain empties into sediment basin number 3 from the C&D landfill, where it appears

that an unknown leachate quantity may have intermixed with stormwater during the rain events and entered the sediment basin. A berm was immediately constructed to prevent further leachate from reaching the slope drain and entering the sediment basin. A response and disposal information summary is provided below:

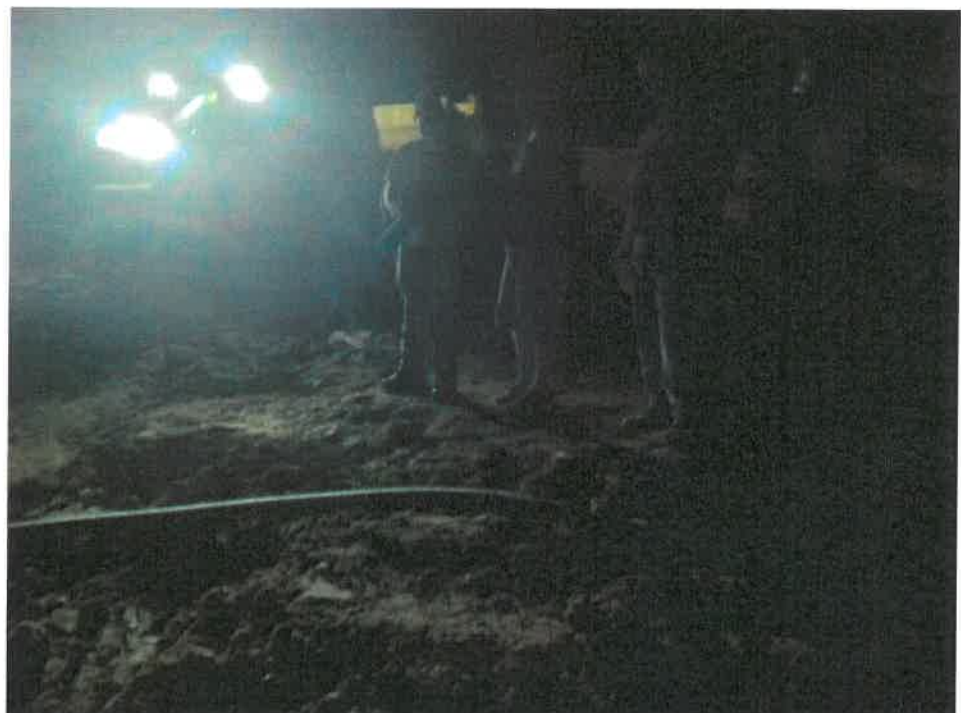
**Photo No.**  
2

Pump and haul operation.

2. Containment: Secondary response included berm construction (shown in **Figure 1**) to contain the leachate within the debris footprint. Pump and haul was instituted to remove contained leachate. Approximately 32,000 gallons were hauled within the first 24 hours.

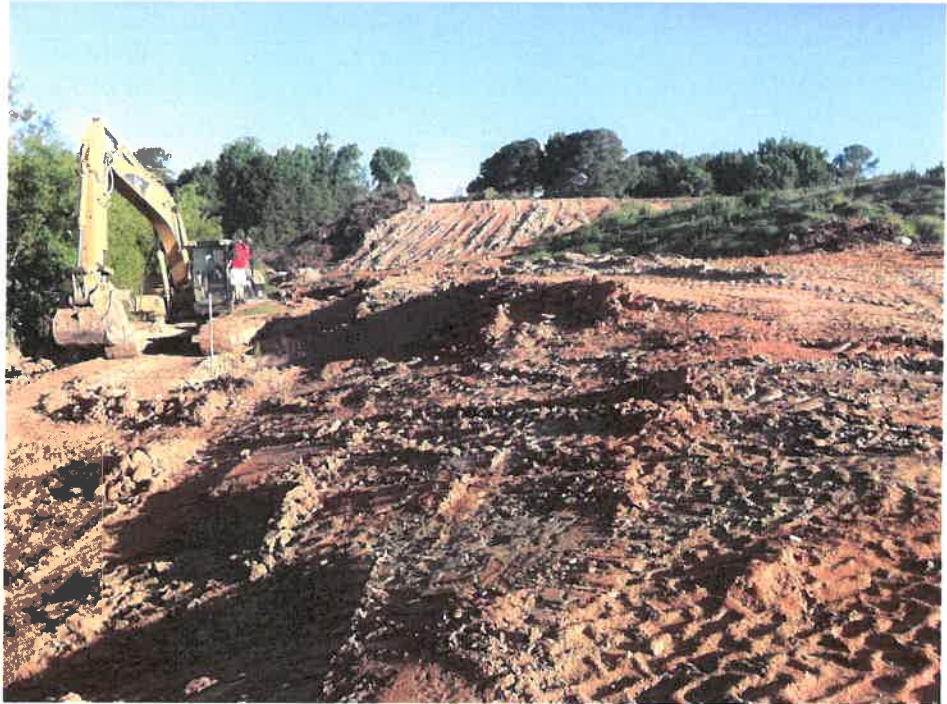
**Photo No.**  
**3**

LCID after basin bridged over and compacted with clay.

1. Plug: Harnett County's initial response was to excavate at two (2) seep locations shown in **Figure 1** (attached) and compact the areas with clay. This method successfully remedied one leachate seep; however, flow from the second was greater that could be contained with the clay "plug".

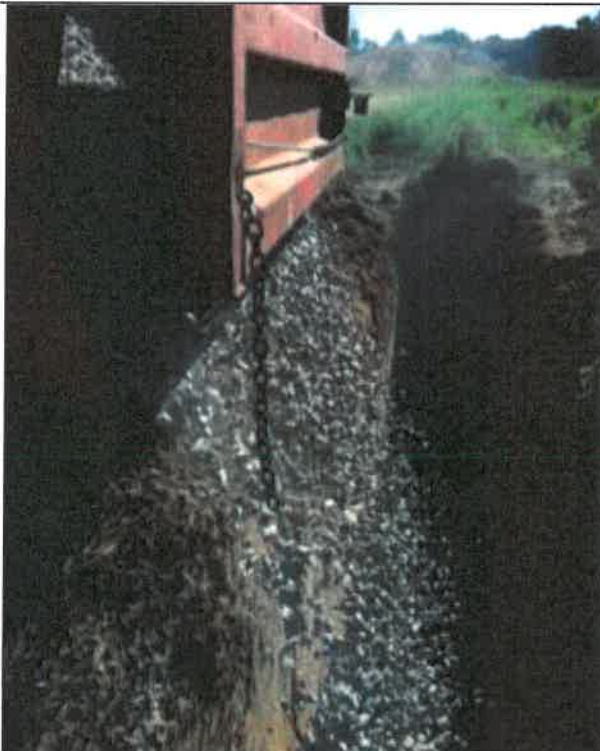
**Photo No.**  
**4**

Stone placed into trench.

3. Trench: With storms threats continuing, pumping did not appear to stabilize the release. Therefore, exploratory test pits were excavated, within the debris limits, to find layers to re-route leachate and promote infiltration vertically. Trenches were excavated and filled with stone in various areas of the debris limits as shown in **Figure 1**. No groundwater was encountered during the exploratory tests and throughout trenching.
